REPLACING WELDED SPINDLE WITH CAST SPINDLE KITS 2-40569 (left) OR 2-40570 (right)

DATE: 20 Sept 2013

Models Affected: All Hydraulic Brake Models prior to Serial Number 58208

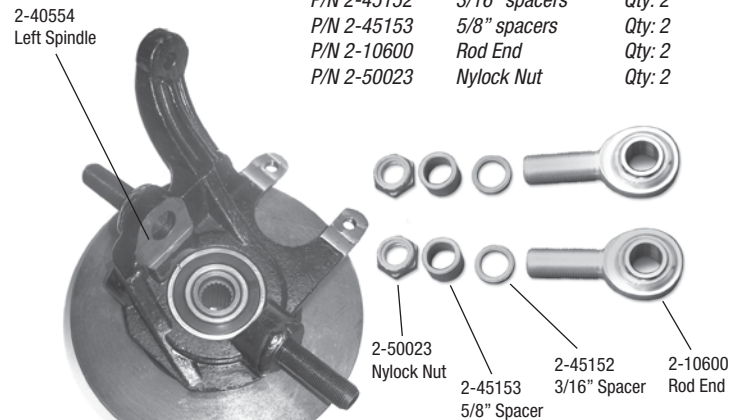
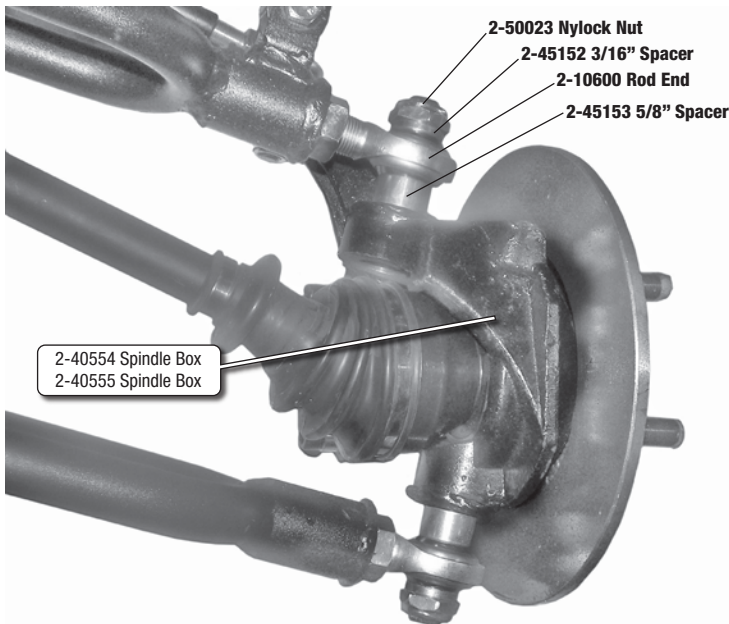
Description of Action: To replace old model welded steel spindle boxes with the new cast spindles.

Solution: The new cast spindles have 3/4" bolts integral to the casting. The rod ends are secured by a 2-50023 Nylock Nut. Spacers are used as illustrated below.
Note: The 2-45152 spacer 3/16" in thickness must install adjacent to the Nylock Nut.

- 1** The wheel and existing spindle box is removed
- 2** Remove existing caliper. The existing studded rod end is removed from the A-Arm and replaced with the 2-10600
- 3** The cast spindle has been supplied with bearings and rotor pre-installed and is a direct replacement
- 4** The 2-45152 spacer must be installed adjacent to the nut. The proper assembly is illustrated as below

(Kit # 2-40569)	P/N 2-40554	Left Spindle	Qty:1
(Kit # 2-40570)	P/N 2-40555	Right Spindle	Qty:1
	P/N 2-45152	3/16" spacers	Qty: 2
	P/N 2-45153	5/8" spacers	Qty: 2
	P/N 2-10600	Rod End	Qty: 2
	P/N 2-50023	Nylock Nut	Qty: 2
