FLIP SEAT TAILGATE HARDWARE INSTALLATION

TSB161

Models affected: All flip seats

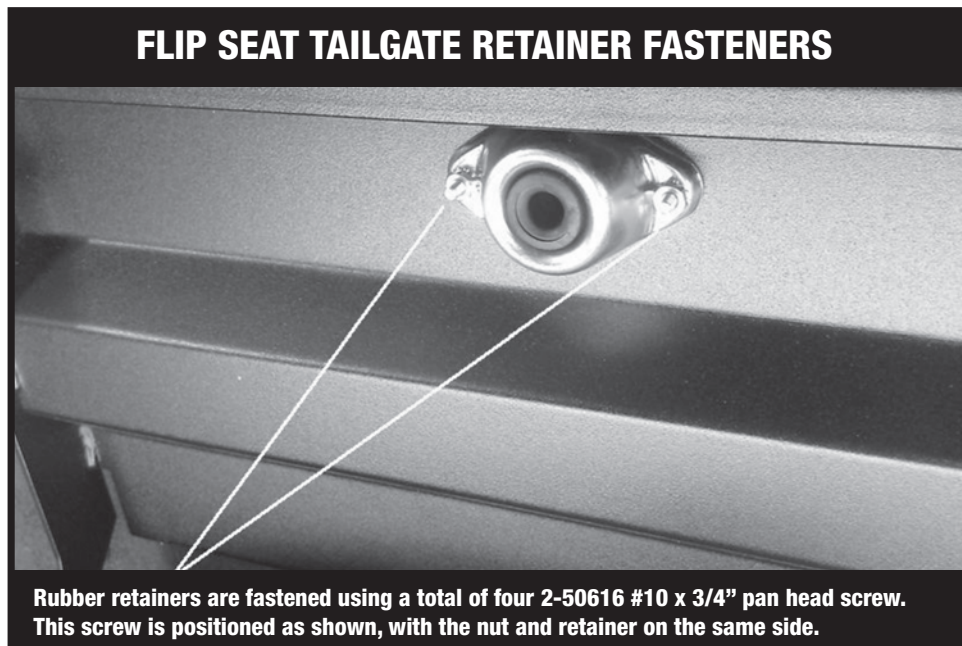
Description of action: To assure that all flip seat tailgates receive the correct hardware

Procedure: This requirement is very straightforward. There were a number of flip seats that were assembled using the incorrect hardware. Please inspect the assembly of the rubber retainers on your tailgate as pictured below. The fastener should be a 2-50616 #10 X 3/4" Pan Head Screw. That fastener may be incorrect, this is determined by measuring the length of the fastener. The incorrect fastener will measure 1" long, rather than the proper 3/4" fastener. If your fasteners measure 1" in length, please replace with appropriate hardware 3/4" in length. If these fasteners are not easily available locally, please call our customer service desk and request qty 4 of the 2-50616 fasteners. Please mention this Technical Service Bulletin and these fasteners will be shipped to you free of charge. In addition, these fasteners should be positioned as shown below, with the #10 nuts on the same side of the tailgate as the retainers. If these are facing the opposite direction, please remove and reverse them.
