HEADLIGHT BEZEL FASTENER INSTALLATION

TSB162

Models affected: Some 2014 200 Series vehicles

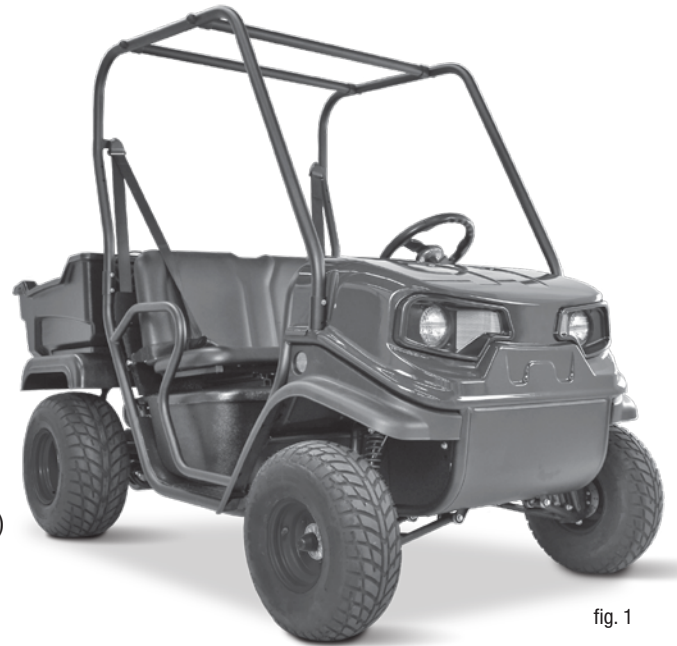
fig. 1

Description of problem: Some models of the American Sportworks TW200 vehicles (2014 model TW201) as shown in Fig (1) have been noted to have headlight bezels that did not fully adhere to the hood surface. In these cases, vehicles should be reworked to the instructions outlined below. Call ASW Customer Service with your vehicle PIN number to have your Replacement Parts shipped to you for this repair at 800-643-7332.
