5210 FUN-KART ENGINE DRIVE BELT

TSB165

DATE: 10 July 2014

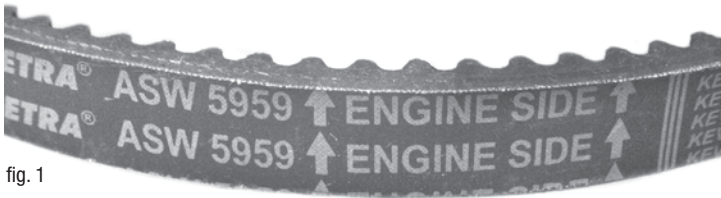
fig. 1

Description of problem: The performance of the torque converter drive system of the 5210 FunKart can be improved by using a new, longer drive belt.

Identifying the issue: Look at the part number noted on the belt. If the part number is 5959 as shown in figure 1, this Technical Service Bulletin applies.

Solution: Replace 5959 belt with the 14704 belt.
