300 SERIES THROTTLE LEVER TENSION

technical service bulletin	prepared by	date
TSB167	Bryan King	24 June 2015

MODELS AFFECTED: BULLDOG 300, CHUCKWAGON 300, LANDMASTER 300 powered by a Kohler 277cc engine between the following Product Identification Numbers (PIN):

DESCRIPTION OF PROBLEM: Throttle may not fully retract to idle position.

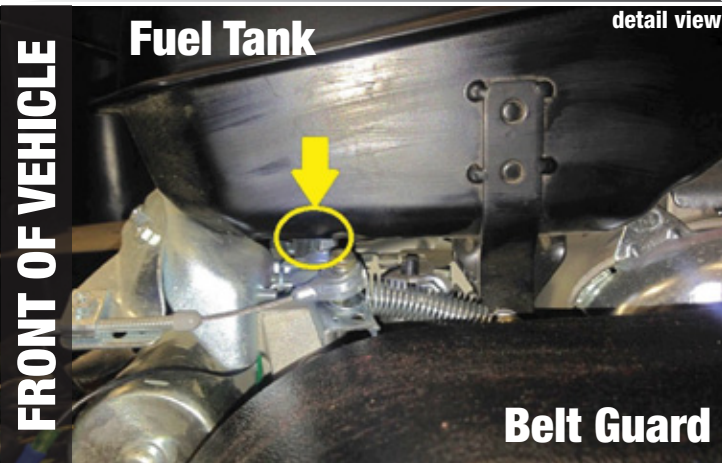
fig. 1

1. Locate the throttle tension nut on the driver side of the vehicle just under the fuel tank (see figure 1).

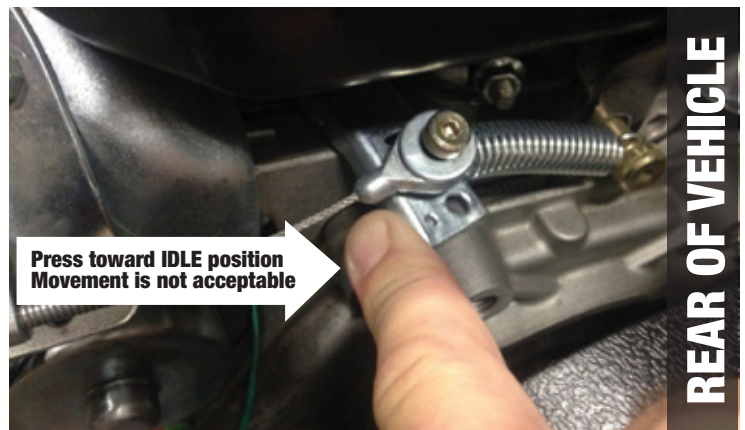
fig. 5

b. With pedal back at the return position, attempt to push the engine throttle lever towards the back of the vehicle as seen in figure 5. Proper adjustment will result in the engine throttle lever at its full **IDLE** position against the stop and no further movement will be noted.
