400 SERIES THROTTLE LEVER TENSION

technical service bulletin	prepared by	date
TSB168	Bryan King	26 June 2015

DESCRIPTION OF PROBLEM: Throttle may not fully retract to idle position.

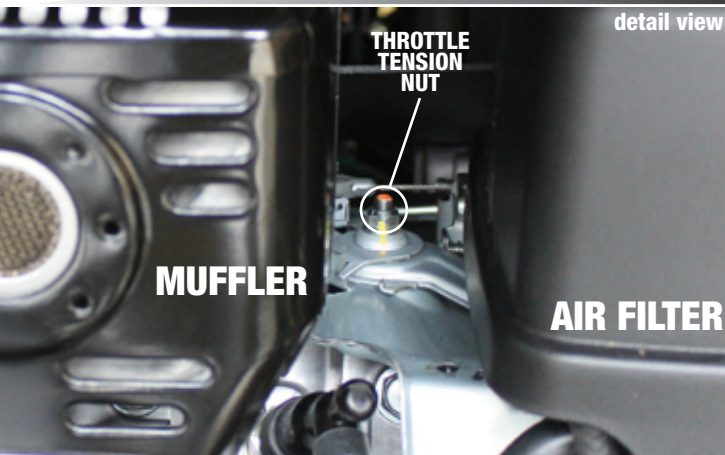
fig. 1

1. From the back of the vehicle, locate the throttle tension nut between the muffler and air cleaner (see figure 1).
